# Manhole Inspection Summary

Manhole # **S19KK\_066MH**

Insp Date: **7/31/09 11:14 AM**

**Location** Address: **BEHIND 1911 CLIFTON AVE**

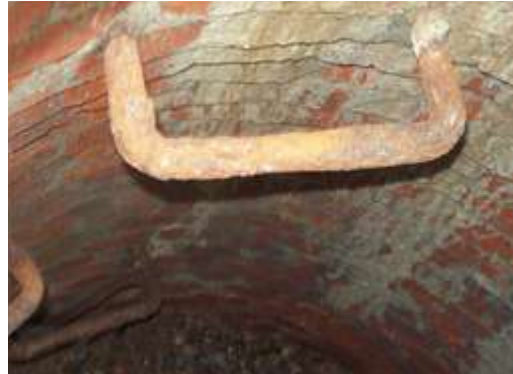
Defect 1

**Steps** Count: **3** Missing: **0** ☒ **Corroded**

CORRODED AND RUSTED STEPS

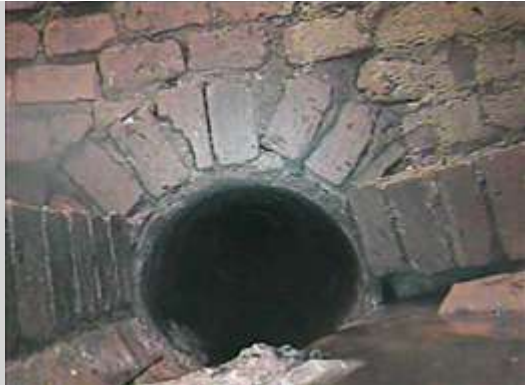
12 O'Clock Outflow

12 in. Circular Gravity Sewer  
Pipe Out @ 12 O'Clock

Pipe Height: (in.) Direct  
Pipe Material: **Concrete** ☐ Pipe Lined  
Invert Depth: **6.78** (ft.) Flow Characteristics: **Slow**  
Deposits: ☒ None ☐ Mud ☐ Sludge ☐ Debris ☐ Grease  
Silt Depth: (in.) Deposits Extent:  
Infiltration: **None** Pipe Seal Cond: **Sound**

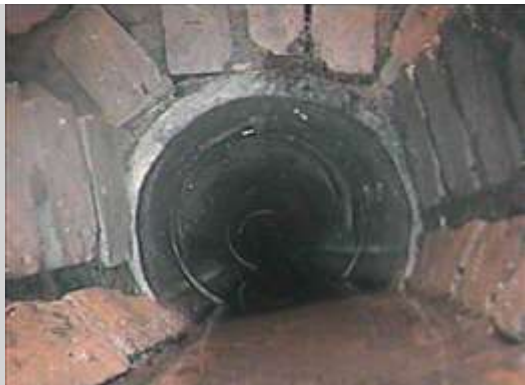
3 O'Clock Inflow

8 in. Circular Gravity Sewer  
Pipe In @ 3 O'Clock

Pipe Height: (in.) Direct  
Pipe Material: **Clay** ☐ Pipe Lined  
Invert Depth: **6.50** (ft.) Flow Characteristics: **Slow**  
Deposits: ☒ None ☐ Mud ☐ Sludge ☐ Debris ☐ Grease  
Silt Depth: (in.) Deposits Extent:  
Infiltration: **None** Pipe Seal Cond: **Sound**

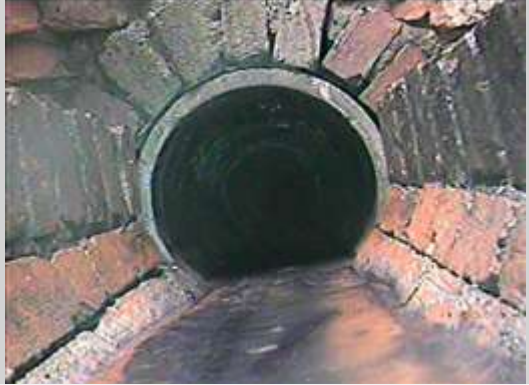
6 O'Clock Inflow

8 in. Circular Gravity Sewer  
Pipe In @ 6 O'Clock

Infiltration: **None** Pipe Seal Cond: **Sound**
